REMOVAL AND FINAL STATUS SURVEY OF HISTORIC AVENUE "N" WOOD STAVE PIPE

NAVAL STATION TREASURE ISLAND,
SAN FRANCISCO, CALIFORNIA

BCT Meeting
February 24, 2016

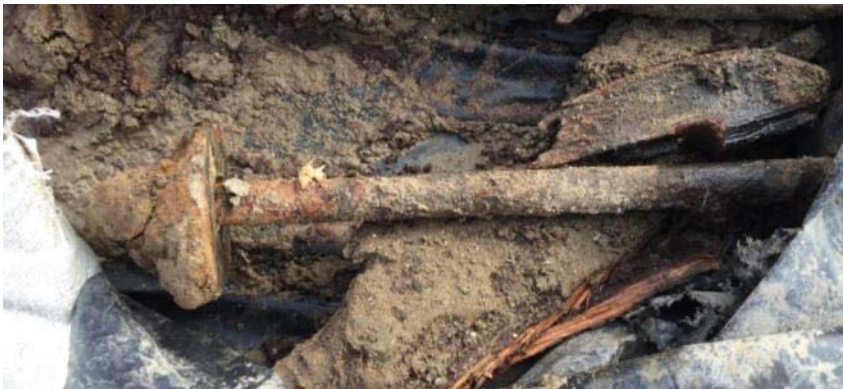
Removed riser and hardware associated with manhole

- Planned excavation of inactive west and east ends is complete
- **West End**
 - Approximately 96 ft long
 - 390 yd³ of material removed
 - 240 yd³: overburden
 - 150 yd³: radiologically impacted
 - Within Section 4W, a manhole was uncovered
 - Concrete slurry appears to have been applied from this manhole during decommissioning.
- **East End**
 - Approximately 12 ft long
 - 48 yd³ of material removed
 - 26 yd³: overburden
 - 22 yd³: radiologically impacted
